BUTLER TOWNSHIP • MONTGOMERY COUNTY • OHIO

# 2725 Stonequarry Road

Single-family ranch • 2130 sq ft • ~1948 • attached garage • Vacant • not occupied

Shaun Atkinson • Ohio HI OHI.2019006734 • expires 12/13/2028 • 937-620-3803

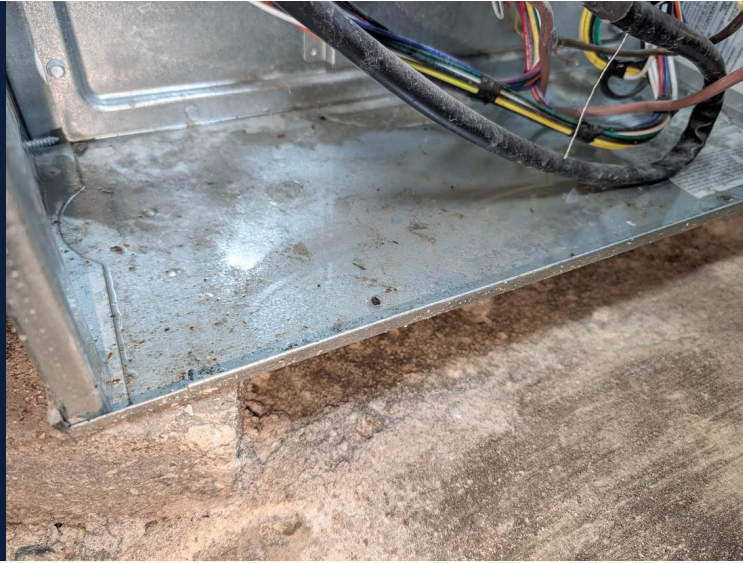
## Standing water in the furnace bottom pan

Trane furnace open for visual. Clear standing water pooled in the bottom pan next to the wiring bundle on the concrete. Water and furnace electrics do not share a pan on purpose.

HVAC tech. Find the source (condensate, leak, seepage), dry it, and confirm the unit is safe to run.

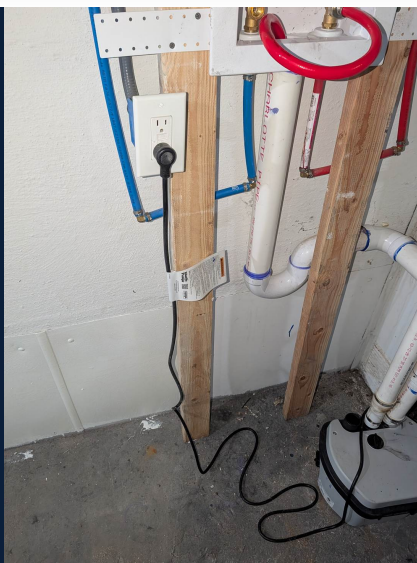
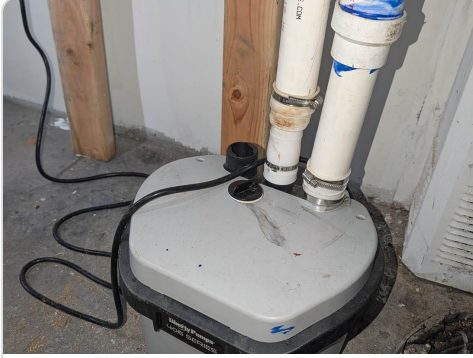
## Sump / ejector pumps on GFCI

Basement has two sump pumps and a Liberty 405 sewage ejector at laundry. On the walk, these pump loads were on GFCI-protected receptacles (Liberty-on-GFCI is photographed). Life-safety intent is fine for wet areas — but nuisance trips on motor loads can kill the pumps until the basement is wet. Flood risk is the issue.

Hire a licensed electrician to evaluate the pump circuits. Prefer dedicated circuits; quality GFCI with alarm if protection stays; and/or battery-backup sump. Keep lids on the pits (separate DIY).

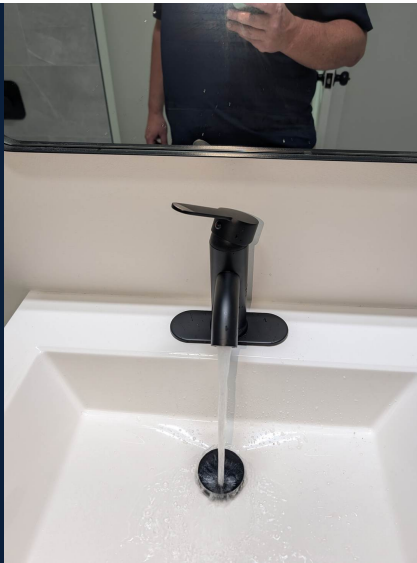
## All hot water • strong sulfur smell

Strong sulfur smell on hot water at every sink tested — not just the bathroom. Whole hot-water side of the system. Common on wells / anode chemistry, but this is house-wide hot, not one faucet.

Hire a Pro — water treatment or plumber for the whole hot system (anode, tank, filtration/chlorination as advised). Don't chase one aerator. Well sample / treatment stays on its own track next to this visual.

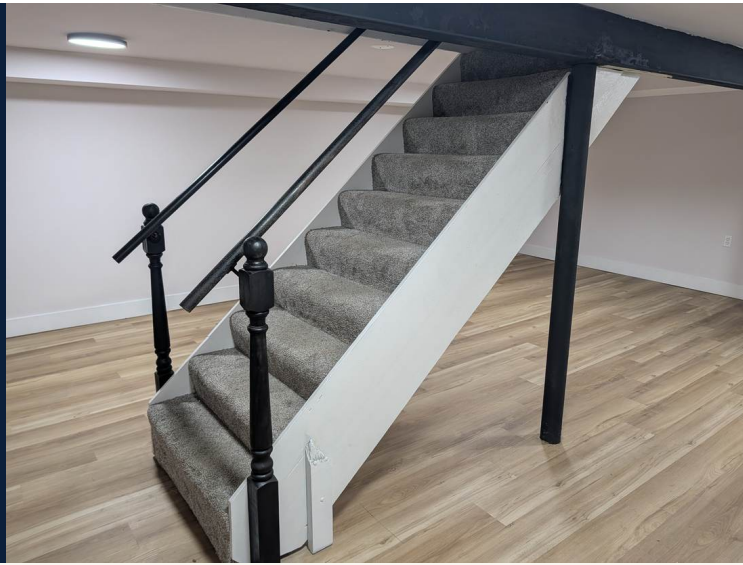
## Stairs • wrong risers + open both sides

This stair run is built wrong. The bottom riser is too tall and the top riser is too short — uneven geometry the whole way up. On top of that, both sides are open with no balusters/spindles. Trip hazard plus fall path left and right.

Hire a carpenter / stair pro. Rebuild or correct riser heights so they're consistent, and install code-minded guards/balusters on both open sides. Handrail continuity while you're in there.

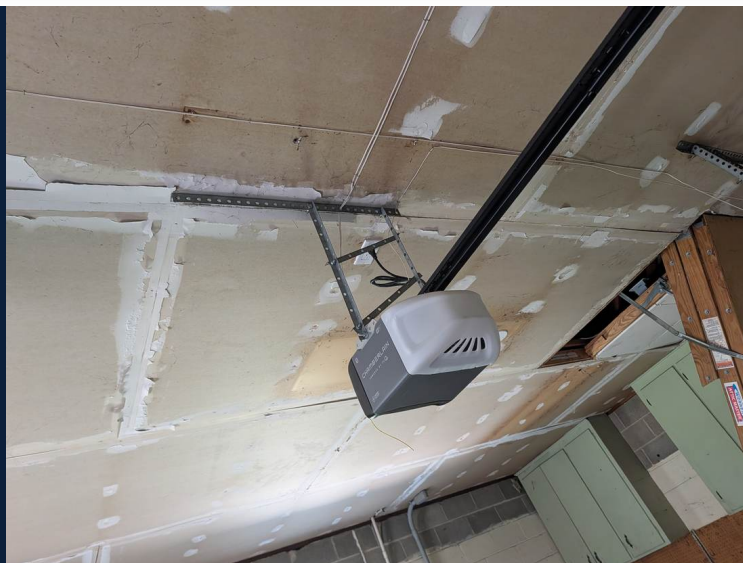
## Both overhead door openers powered but won't run

Both garage overhead door openers have power — lights/indicators blinked when the buttons were pressed — but neither door moved. Not a dead outlet. Operators answered the button and still did nothing. Because neither door traveled, auto-reverse and photo-eye safety were not demonstrated.

Hire a garage-door technician. Trace logic boards, sensors, force settings, rails, and operators on both doors. Power is present; travel isn't. Both openers were tested on site (power present, button press, no travel). Photo shows the opener area documented on the walk.

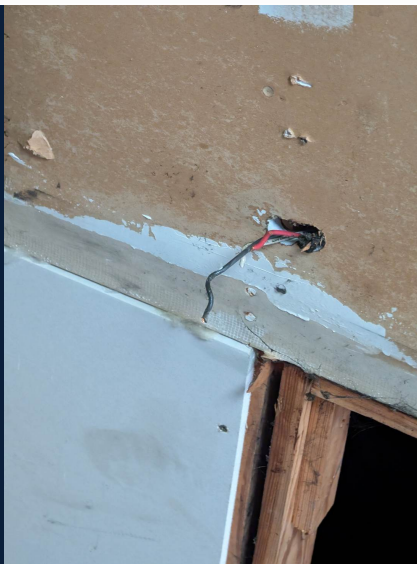
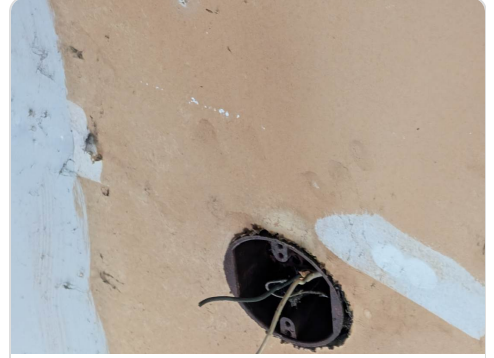
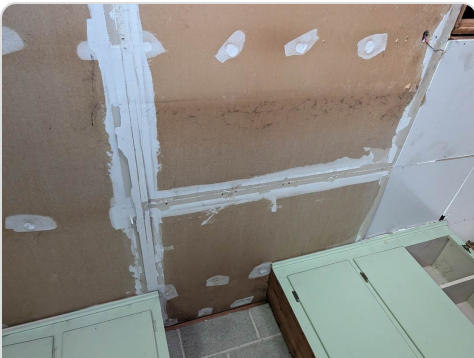
## Garage • exposed wires + open junction boxes

garage leftovers on the electrical side: black/red conductors hanging from a wall hole with stripped copper showing, and an open octagon box with unterminated conductors — no cover, no fixture. That's live-looking work left open. Ceiling finish damage is a separate Hire a Pro.

Hire a licensed electrician. Terminate in boxes, install covers/fixtures, kill abandoned ends properly. Don't paint over open splices.

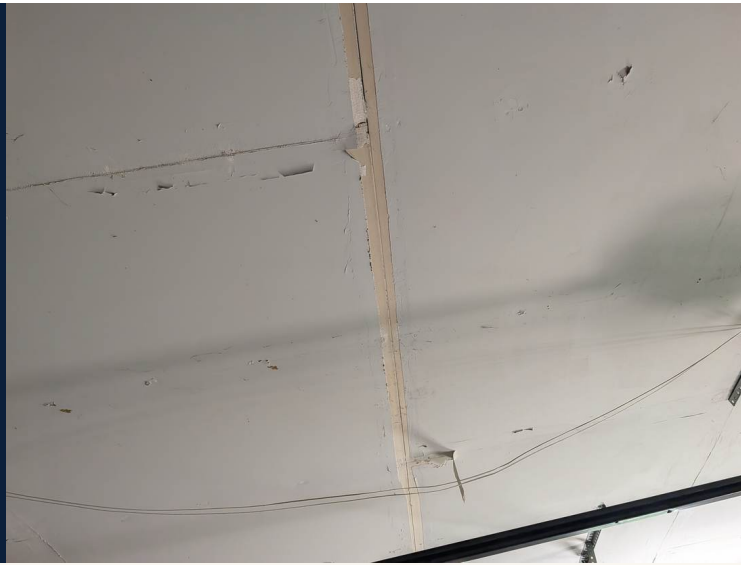
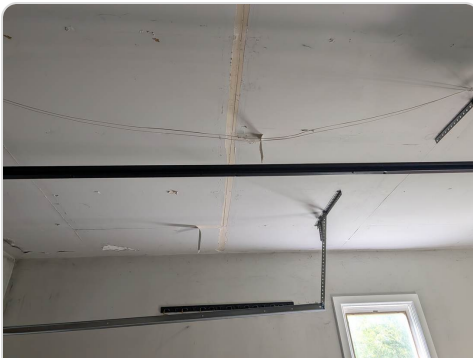
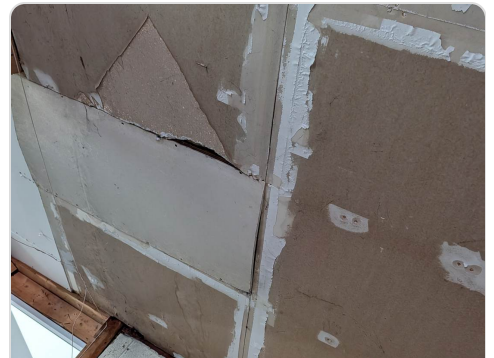
## Garage ceiling • widespread finish / moisture damage

Garage ceiling is a mess across multiple bays — not one cosmetic spot. Peeling joint tape and mesh, flaking/bubbling finish, unfinished fiberboard patches, circular and yellow-brown stains, sagging unsecured low-voltage wires along the opener rail, and failed mud/tape at the upper wall/ceiling line. Looks like old moisture + failed finish work, not a single nail pop.

Hire a Pro — drywall/moisture pro (and electrician if open splices stay in play). Find whether the leaks are dead or active, dry it, then repair/replace the damaged ceiling finishes. Opener area cutouts and open boxes are part of the same story. Exposed live conductors stay the separate electrical Hire a Pro.

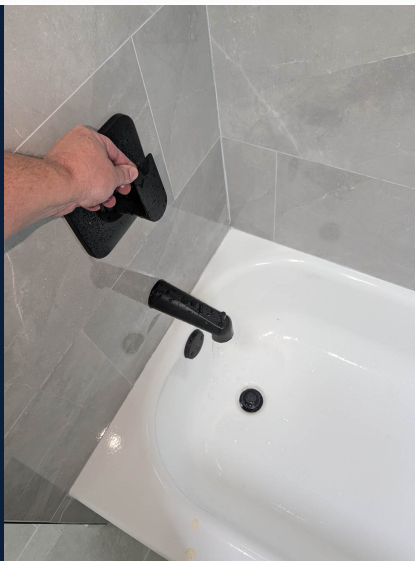
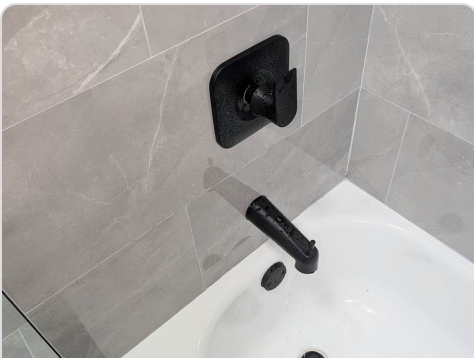
**Shower valve installed incorrectly**

Shower valve is installed incorrectly — trim, cartridge, and handles are not in the right position. This is not a cosmetic loose plate; the assembly orientation is wrong.

Hire a plumber. Correct the valve installation so the cartridge/handles/trim sit in the right position. While it's open, check for moisture behind the wet wall.

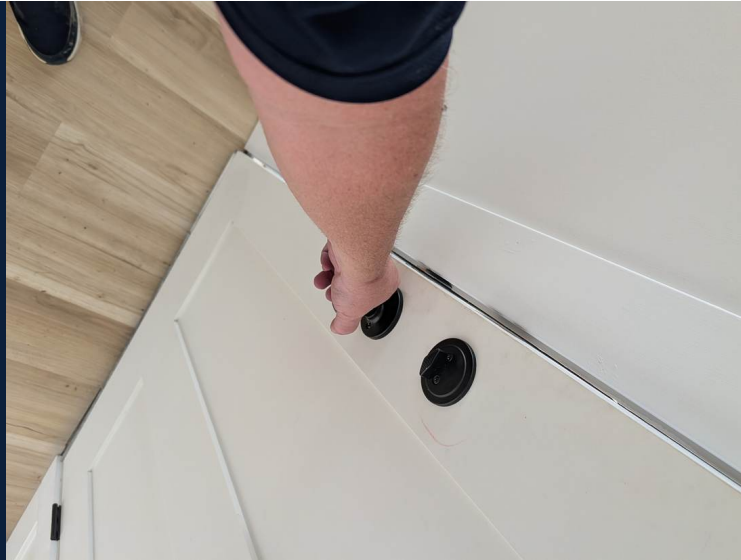
## Front entry door sagging • loose hinge

Front entry door (deadbolt) sags on a loose hinge — hard to close / line up cleanly. Separate from the first-floor bedroom door.

Hire a Pro (carpenter / door tech). Secure the loose hinge into solid framing and re-hang so the entry closes square without sagging. Stripped hinge holes → longer screws into the stud or a hinge repair kit.

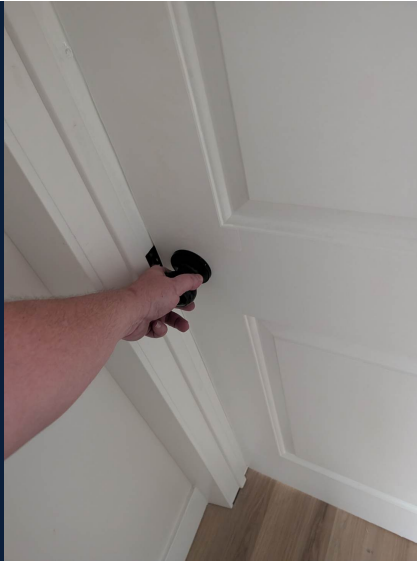
## First-floor bedroom door will not close

First-floor bedroom door (no deadbolt) does not line up in the jamb and will not close fully. Latch side hits the stop / frame. Separate from the front entry.

Hire a Pro — carpenter. Re-hang / plane / adjust so the bedroom door closes and latches.

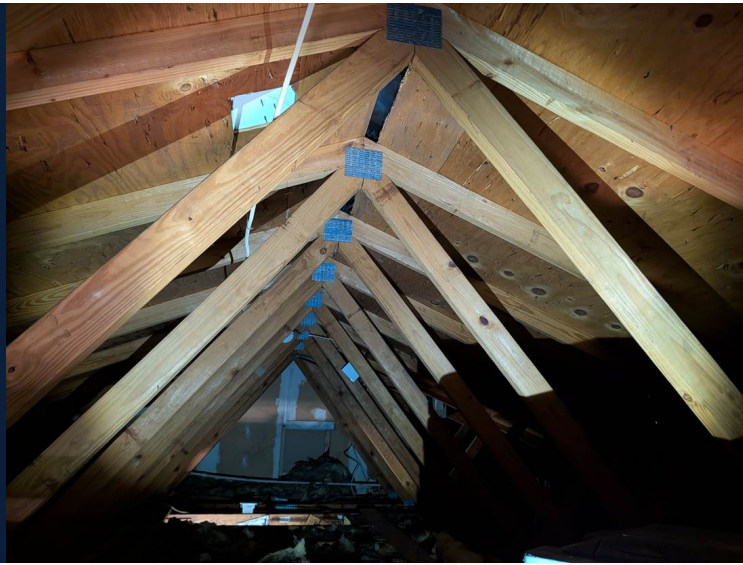
## No attic access to house roof framing

Only the garage attic was entered (Werner pull-down). There was no attic access to view the house roof framing over the living area — rafters/trusses, sheathing, leaks, ventilation, insulation over the house. That is a major gap on a ~78-year-old ranch, not a footnote.

Hire a Pro / require access before you rely on this report for the roof structure. Seller or agent needs to provide a house attic hatch/pull-down, or budget a return visit / invasive opening so framing and roof deck over the living space can actually be seen. Garage attic is not a substitute.

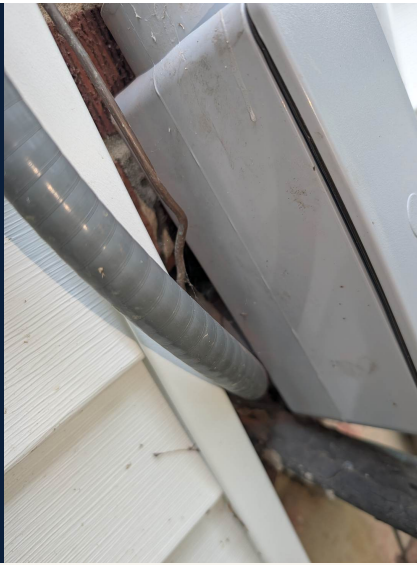
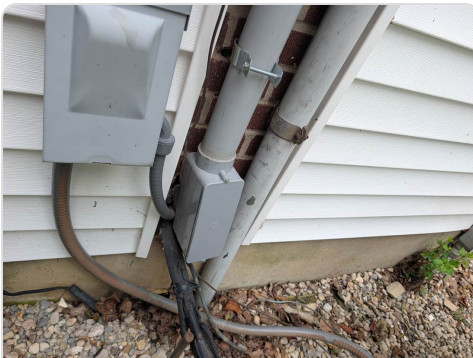
## Unsealed penetrations at AC disconnect / siding-brick

Large open gaps where conduit, ground, and refrigerant lines pass the siding-to-brick transition at the outdoor disconnect. Pest and weather door.

Exterior-grade sealant / foam for penetrations. Kill power at the disconnect first — or hire an electrician if you are not comfortable working next to live gear.

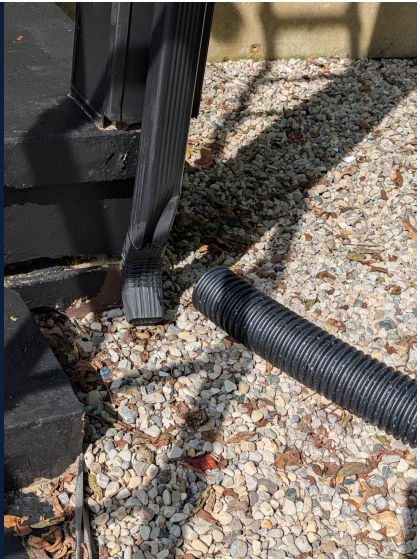
## Downspout elbow damaged / disconnected from leader

Downspout is damaged at the bottom: the elbow is disconnected from the leader pipe, so water dumps at the foundation instead of into the extension. Needs to be reattached (and the damaged section

fixed/replaced if it won't seat).

DIY!: reattach the elbow to the leader with proper fittings/screws, then reconnect the extension so discharge is several feet from the wall. If the elbow/leader is crushed or split, replace that piece first — don't just jam it.

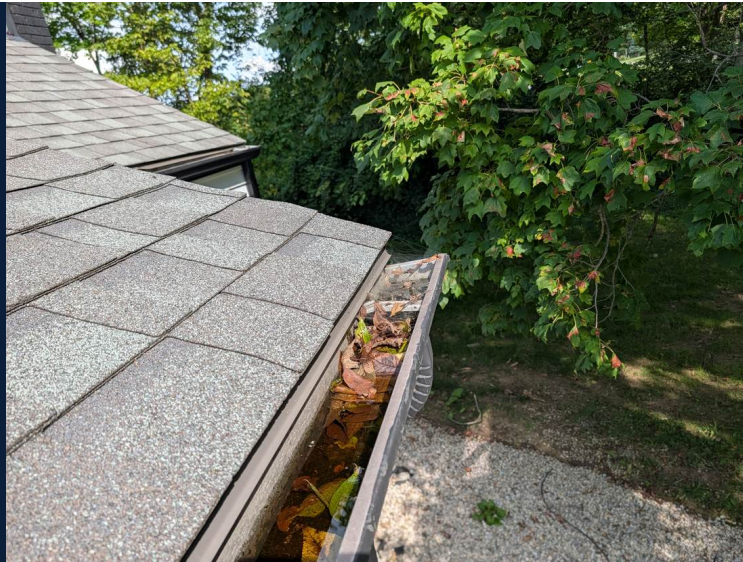
## Gutter clogged • standing water

Gutter packed with wet leaves and holding water under tree overhang. Overflow sends water to the foundation instead of the downspout.

Clean gutters and downspouts. Flush until water runs free. Schedule after leaf drop.

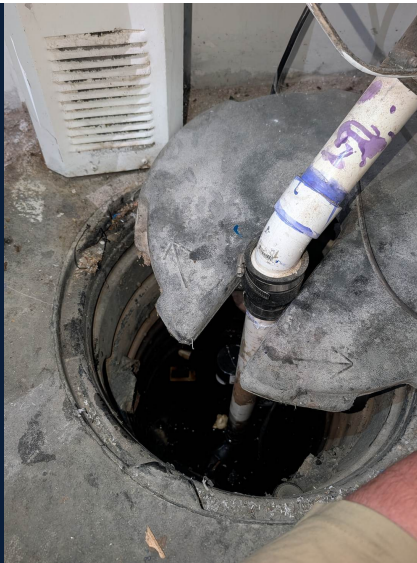
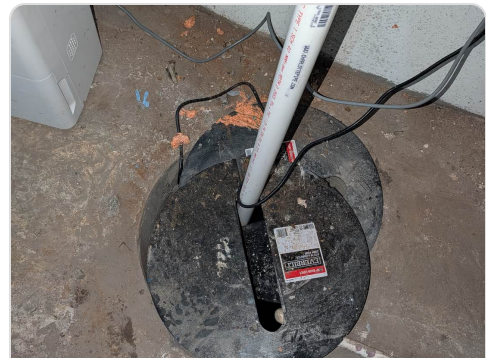
## Sump lids open / askew

Sump covers displaced — askew two-piece lid with open water visible, and an Everbilt cover leaving a gap around the discharge. Trip hazard and moisture path into the basement air.

Reseat or replace the lids so the pits are covered. Cut neat holes for the discharge if needed. (Pump-on-GFCI is a separate Hire a Pro.)

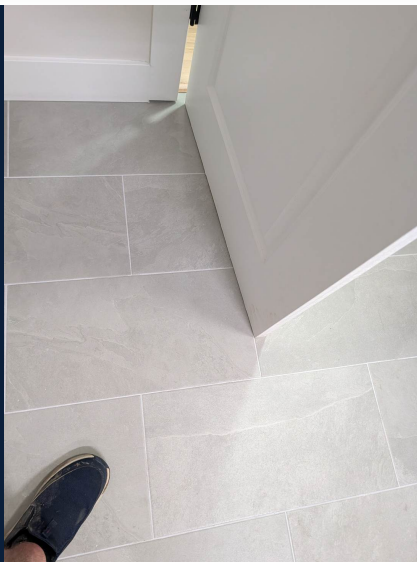
## Bathroom door • trim the bottom

Bathroom door contacts the tile at the bottom — the slab is long. Clearance fix is a bottom trim, not hinges, not a full re-hang.

DIY!: take the door down, trim a hair off the bottom, sand/seal the cut edge, rehang. If you've never trimmed a door, a carpenter still makes short work of it — but this is a bottom cut.

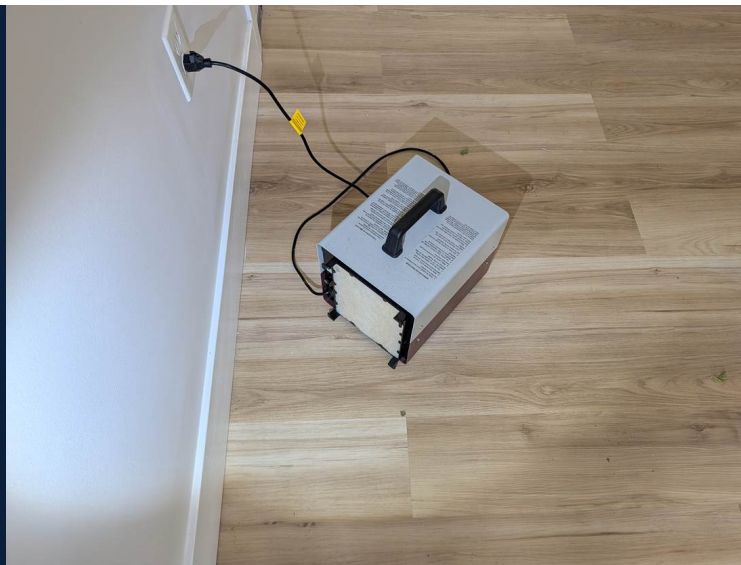
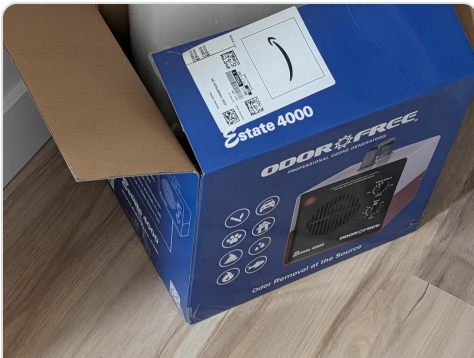
## Ozone generator was running on arrival

OdorFree / professional ozone generator was running when the inspector arrived. Unit was shut off for the walk. Ozone machines are used to knock down odors — they are not a repair, and running one in an occupied walk is a tell that someone was masking or treating air.

Noted. Ask what odor they were chasing and whether anyone will be living here with the machine off. Ozone is not a substitute for finding the source. Fuel-oil odor (separate finding) matters more than the box.

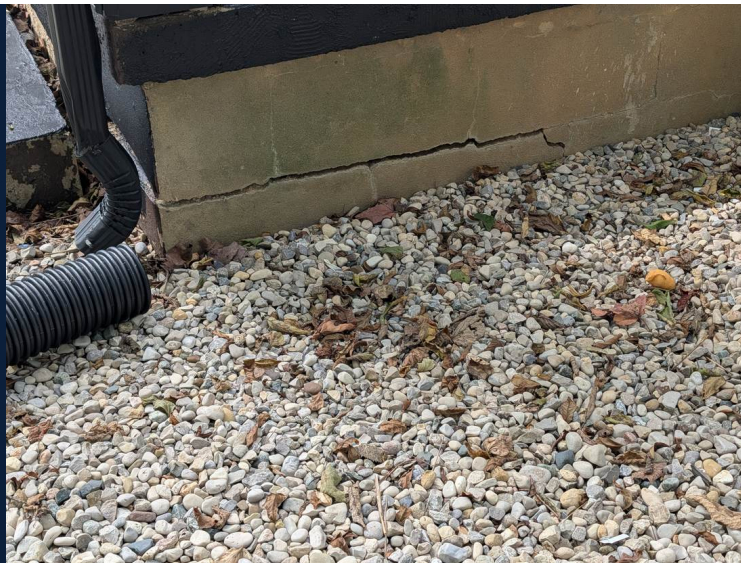
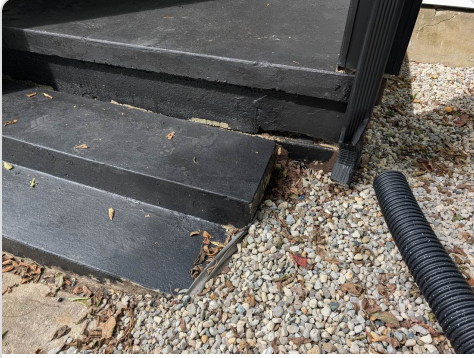
### Foundation / stoop / steps • settlement (78-year-old house)

Parged CMU shows a horizontal crack near grade at the same story as the front stoop and steps, which have clearly settled. On a ~78-year-old house this reads as long-term settlement/movement — worth watching, not a brand-new structural emergency from this photo set alone.

Noted settlement on a ~78-year-old house. Monitor the crack and stoop for change. Keep water off the wall — reconnect downspout extensions (separate DIY). If the crack widens, the stoop drops more, or doors start binding from movement, then budget a foundation contractor.

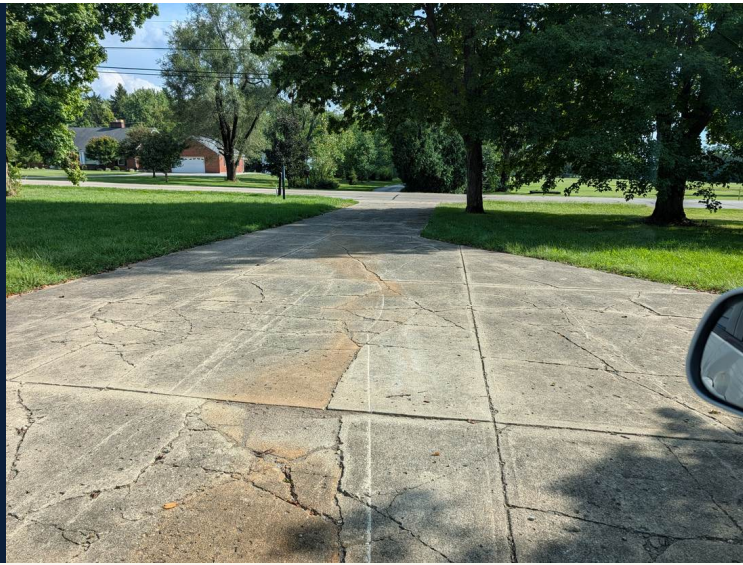
## Driveway • extensive cracking

Concrete drive shows long longitudinal cracks, alligatoring, and mineral staining along a crack. Uneven at some crack lines — monitor. No single clear trip ledge called from the photo alone.

Noted. Monitor. Budget sealant / panel work later. Call a flatwork contractor if edges become trip hazards.

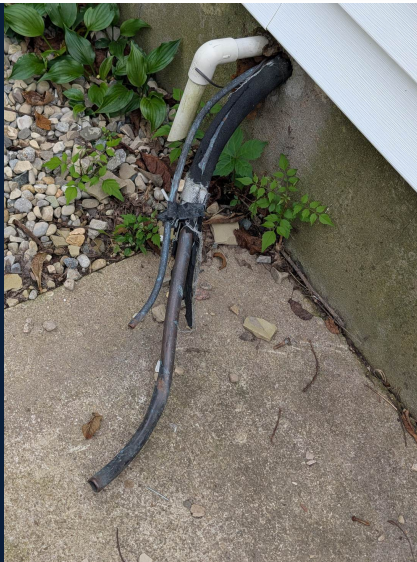
## Abandoned / cut refrigerant lines at foundation

Old refrigerant lines at the foundation: torn insulation, cut copper, PVC drain elbow nearby. Looks like a prior system left behind. Seal the hole when the lines are confirmed dead (pairs with the unsealed penetration DIY).

Noted. HVAC can confirm abandonment and remove or cap. Seal the wall penetration.
