BUTLER TOWNSHIP • MONTGOMERY COUNTY • OHIO

# 2725 Stonequarry Road

Single-family ranch • 2130 sq ft • ~1948 • attached garage • Vacant • not occupied

Shaun Atkinson • Ohio HI OHI.2019006734 • expires 12/13/2028 • 937-620-3803

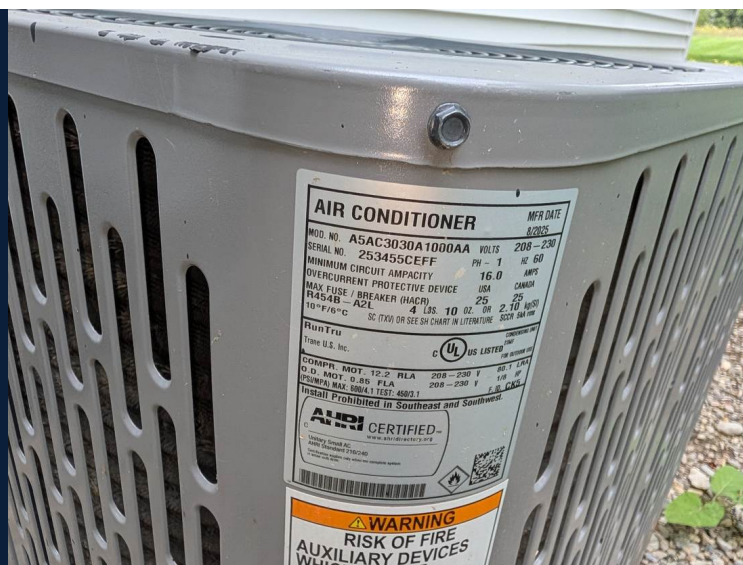
## The big machines • how old is this stuff?

Most of the expensive gear here is basically brand-new (2025 stickers). That's good news for the first years of ownership — less surprise replacement risk on heat, AC, and hot water. Register warranties and keep the manuals.

Nameplate inventory only — not a warranty claim and not a promise of remaining life. Standing water in the furnace pan and the GFCI-fed pumps are separate Hire a Pro items.

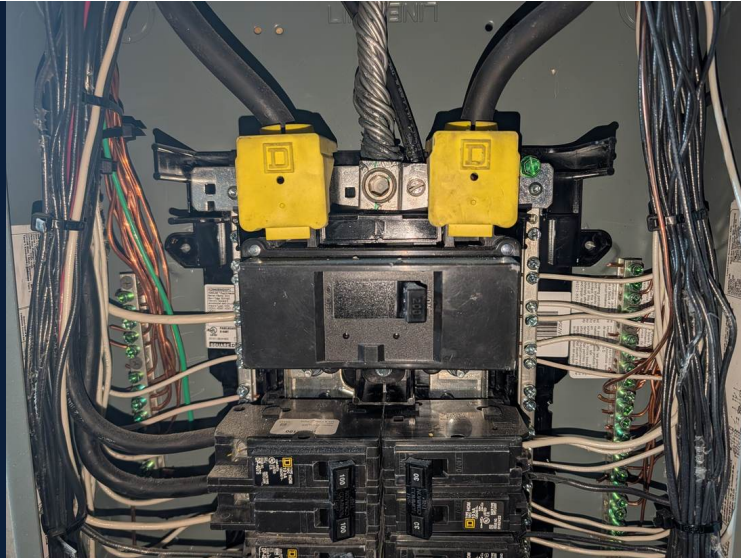
## Two electrical panels · covers off on the walk

This house has two breaker panels — a main panel for the house and a second panel in the garage. Both covers came off on the inspection so the insides could be looked at, not just the doors. That matters: you want proof someone actually opened them, not a photo of a closed gray box.

Noted for the buyer. Main service is a full-size 200A setup; the garage has its own subpanel feeding that side of the house. Nothing here is a “replace the panel tomorrow” call from these photos alone. The

separate Hire a Pro is the open/unfinished wiring in the garage — that's the electrical issue that needs a pro, not a brand trivia contest.

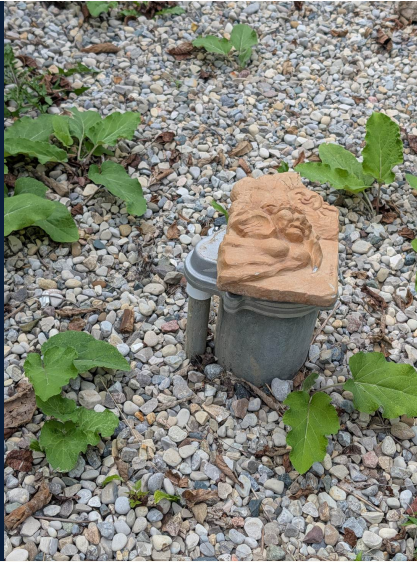
## Private well present

Private well serving the house — Well-Rite pressure tank, manifold (switch/gauge/drain), whole-house filter on a DIY frame, plus the labeled 20 gal expansion tank (precharge 38 psi, date code 01/20/25). Well head out at grade.

Noted. Well equipment is present and labeled. Sulfur on hot water is the separate Hire a Pro. Keep well sampling / treatment on its own track.

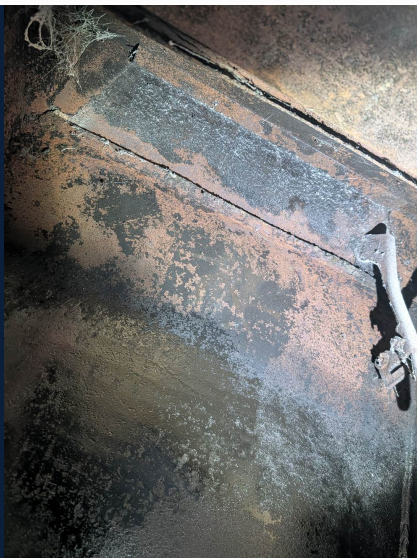
## Fireplace damper • documentation shot

Photo of the damper / firebox interior was taken for the file. Per inspector: documentation only — not scored as a defect from that shot. Not a Level II chimney inspection.

Noted. If you burn wood, book a chimney sweep / CSIA look before first fire.

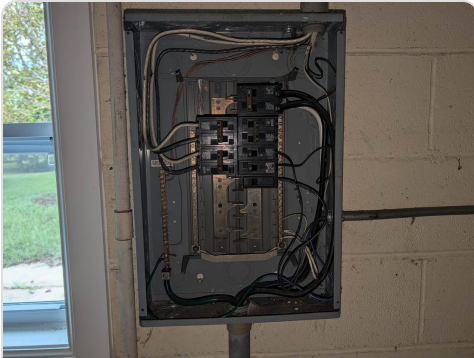
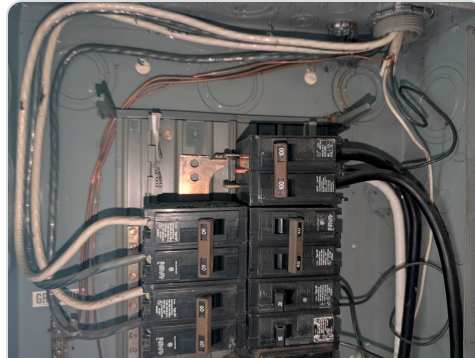
Two electrical panels · covers off on the walk

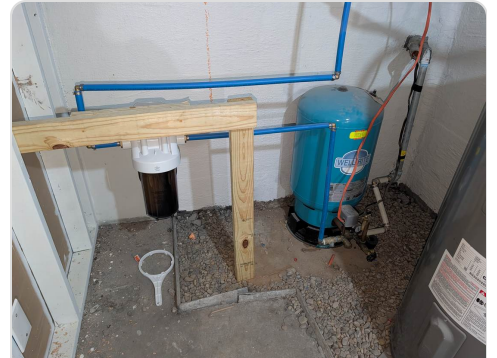
Private well present

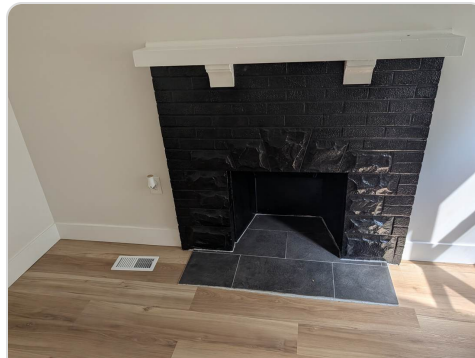
Fireplace damper · documentation shot
